Manhole Inspection Summary

Manhole # S29E__043MH

Location Address: **222 N. Pine**

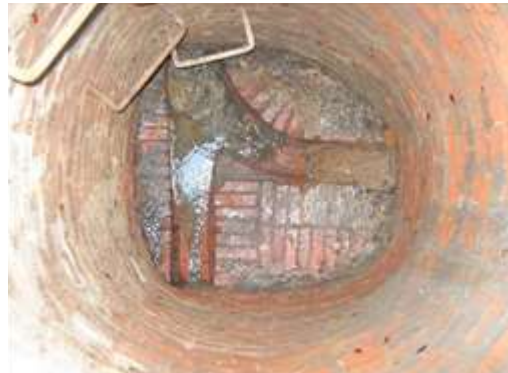
Top View

shows debris in channel

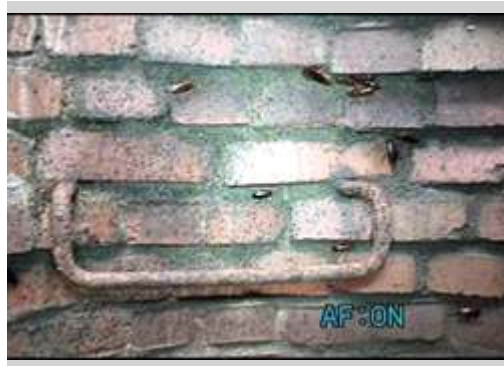
Defect 5

Count: **7** Missing: **0** ☒ **Corroded**

oxidized rungs

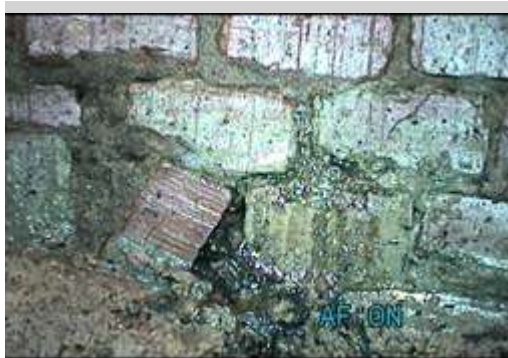
Defect 3

Infiltration: ☐ None ☐ Joint ☐ Cracks ☐ Mortar ☐ Roots ☒ **Wall**

infiltration three oclk area

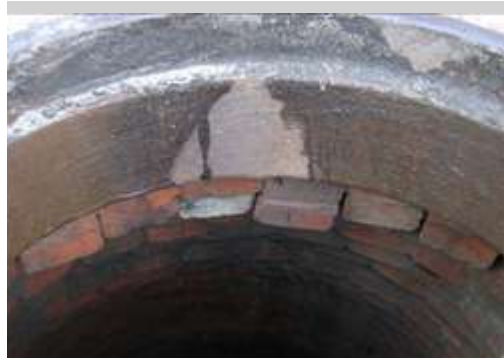
Defect 2

Condition: ☐ Sound ☐ Cracked ☒ **Leaks**

inflow / Infiltration from top

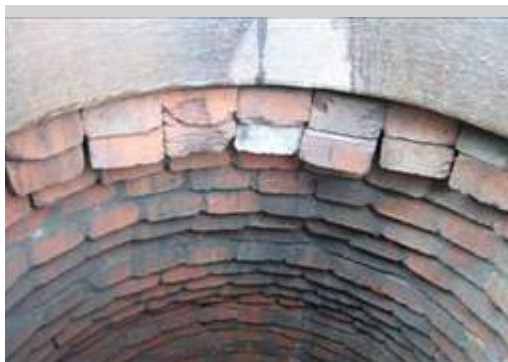
Defect 1

Condition: ☐ Sound ☐ Cracked ☐ Root Intrusion ☒ **Loose Brick** ☒ **Deteriorated**

loose bricks and missing mortar

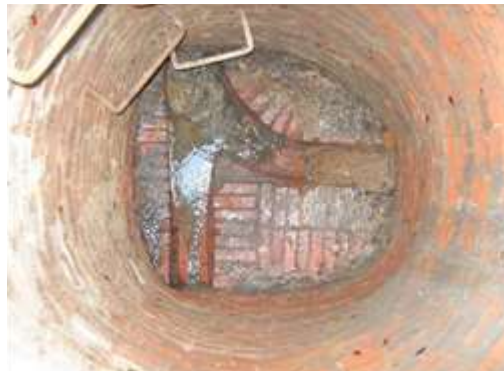
Defect

Condition: ☐ Sound ☐ Cracked ☐ Root Intrusion ☐ Deteriorated ☐ Leaks ☒ **Debris**

debris in channel
